Technical Report on MainOne Submarine Cable Restoration

July 2017

MainOne

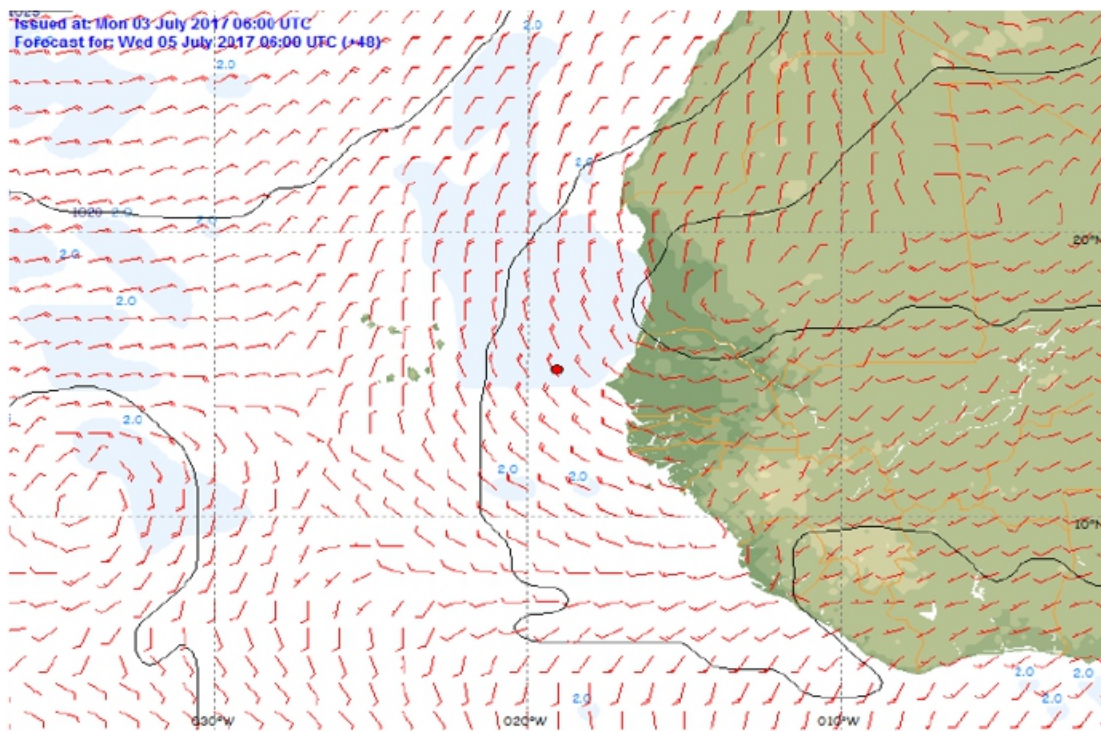
The cable was successfully grappled and cut off and the vessel turned around and did the same with the Portugal facing end. Following the cutting runs, the vessel executed the holding runs to lift the cable ends on board. This provided evidence of the specific nature of the fault and the cable was successfully retrieved save for one kilometer cable length which broke off under tension. Visual inspection of the retrieved cable then confirmed the probable cause of some sort of landslide on the sea bed which unfortunately trapped and crushed the cable thus resulting in a cut to both the fiber and power cables within the cable enclosure. This point of breakage is shown in a picture of the end of the retrieved cable below.

Figure 3: Red dot - location of cut

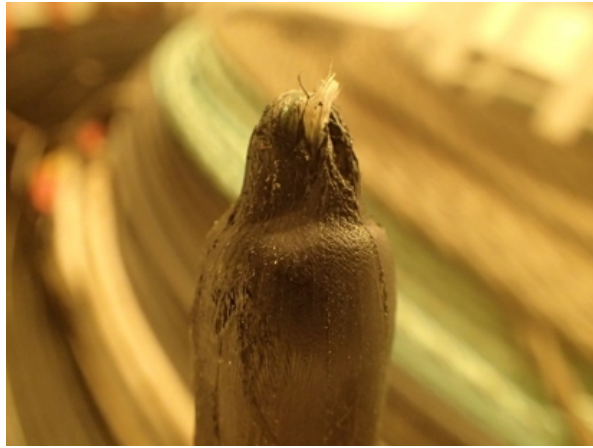
Figure 4: Cut Cable end

To complete the repair, the engineers now needed to replace the damaged section of cable with properly matched fiber cables for effective performance and also added length to compensate for placement of the cable back on the seabed at such water depths. The engineers did the initial splice of the replacement fibers to the existing cable and performed ship based testing to ensure performance.

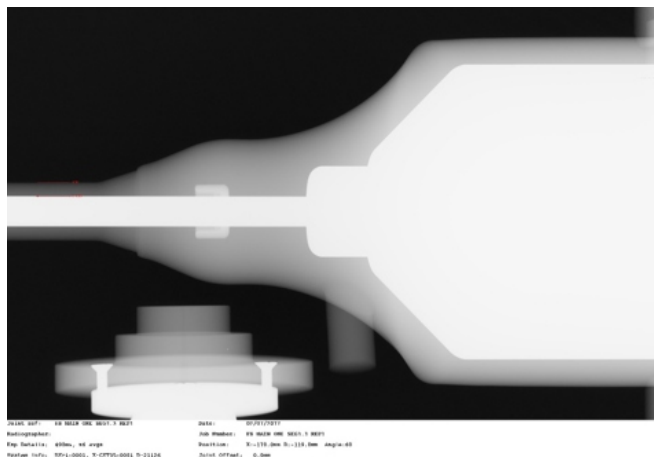
On favorable review by all parties, the repair was deemed as having passed the test. In addition, x-ray images of the final spliced cable were captured and shared with the technical team to ensure good quality joints with no inclusions in the molds thus ensuring longevity of the cable system underwater as expected going forward. On confirmation of approval by the MainOne Submarine lead, Mr. Bernard Logan, the cable system was again powered down by the terminal stations and the vessel started the process of lowering the submarine cable back to the seabed and guided into position.

Figure 5: X-ray of spliced cable
